GA-C21284
5/93

CERAMIC FIBER COATINGS DEVELOPMENT AND DEMONSTRATION

FINAL TECHNICAL REPORT

GA PROJECT 3858

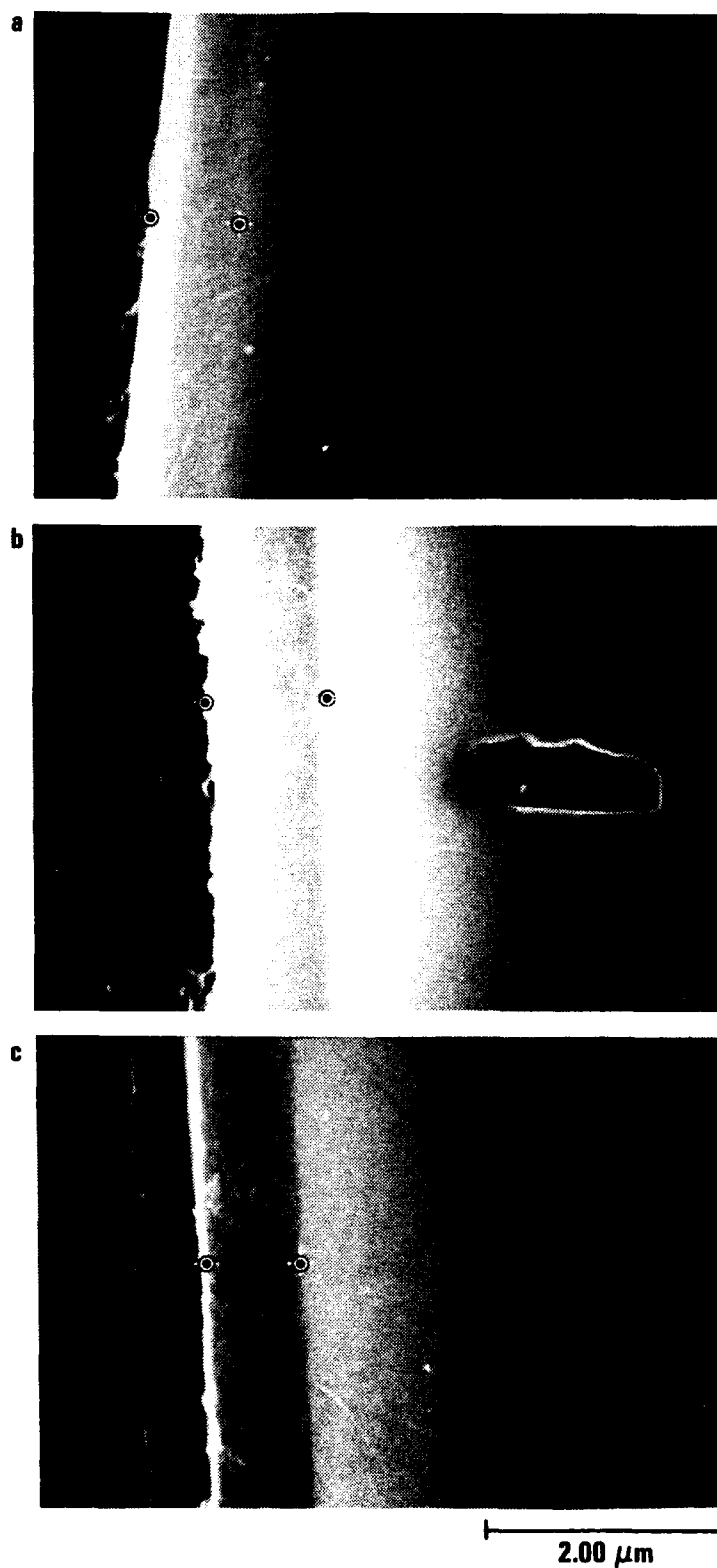
Figure 1. Scanning electron micrographs of BN coated SiC substrates after two hour heat treatment to (a) 1000°C (b) 1200°C (c) 1400°C. The distance between circles is given in bottom right corner of micrograph.

Coating characteristics and any apparent reaction zones were determined by scanning electron microscopy (SEM). After heat treatment, the boron nitride coatings adhered only to the alumina and silicon carbide substrates. The BN coated Al_2O_3 substrates were studied only at 1000° and 1200°C but appeared to have adherent coatings at both temperatures with no evidence of any chemical interaction. The BN coated SiC couples maintained adherent coatings at 1000°, 1200° and 1400°C. The measured coating thickness was slightly larger in the 1200°C sample than in the other two samples, but Figure 1 shows no evidence of increased porosity. Therefore, this difference is probably due to variation in the initial coating

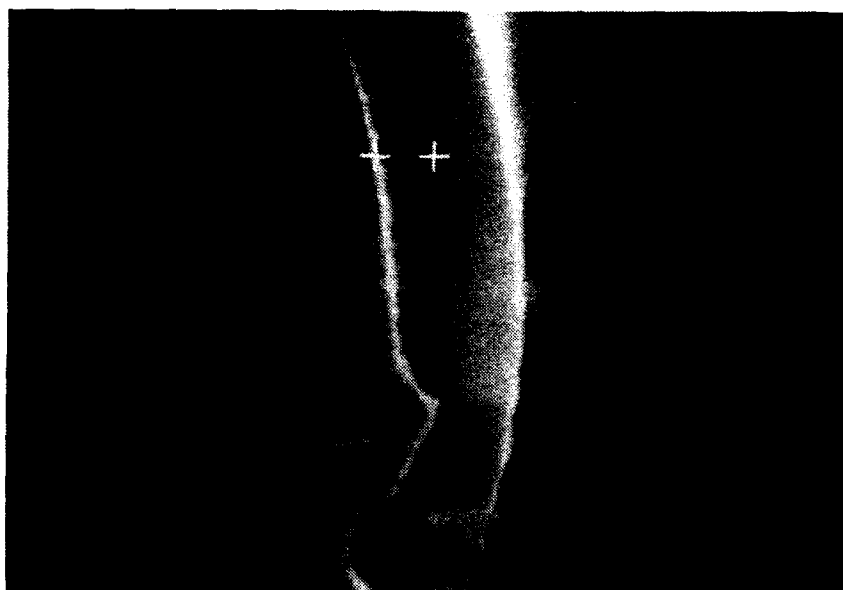
Figure 37. Scanning electron micrograph (15000X) of dual coating consisting of BN followed by SiC on a Nicalon fiber substrate prepared in static coater.

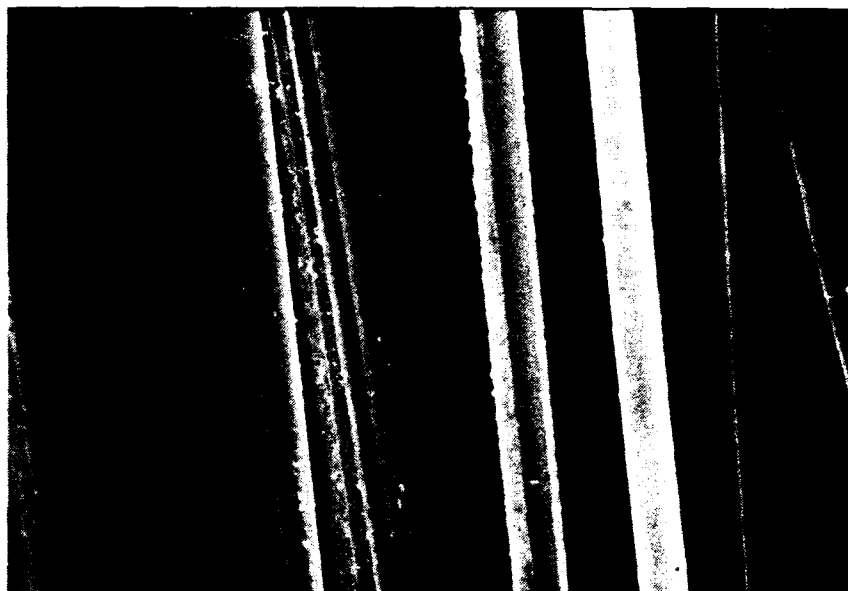
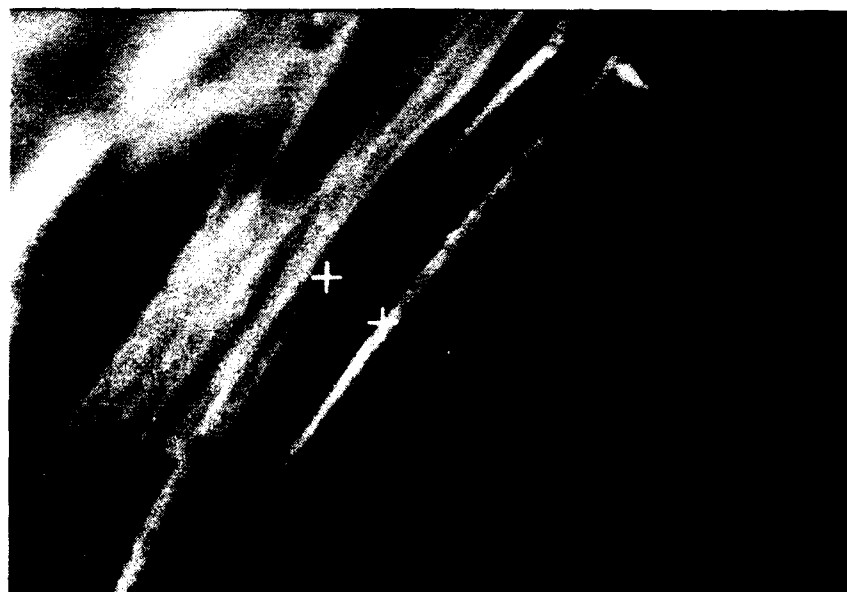
Figure 46. Scanning electron micrographs (top panel 500X, bottom panel 30,000X) of the yttria coated Nicalon coated continuously from yttrium nitrate coating solution.

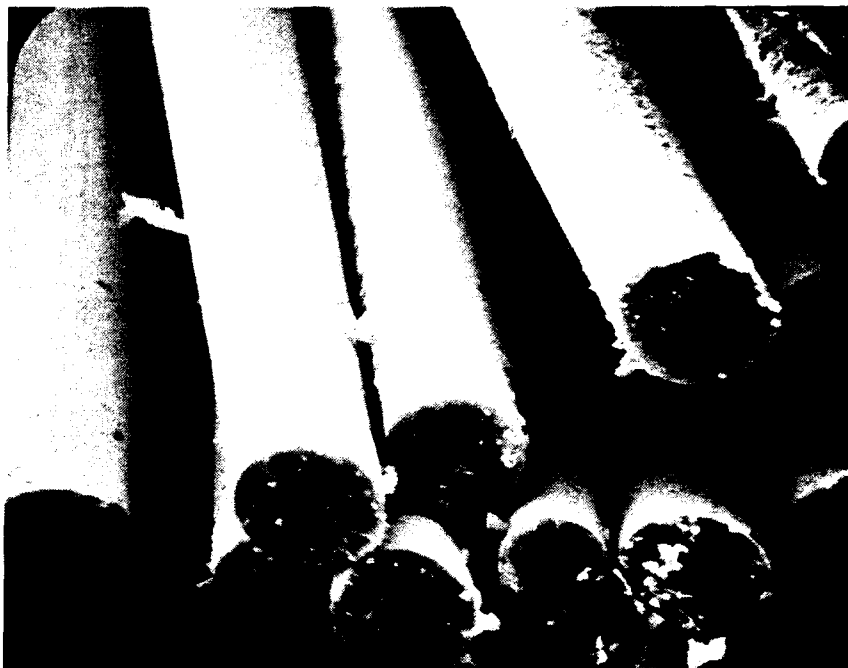
Figure 55. Scanning electron micrograph of BN-coated Nicalon derived from decaborane polymeric precursor (1000X).

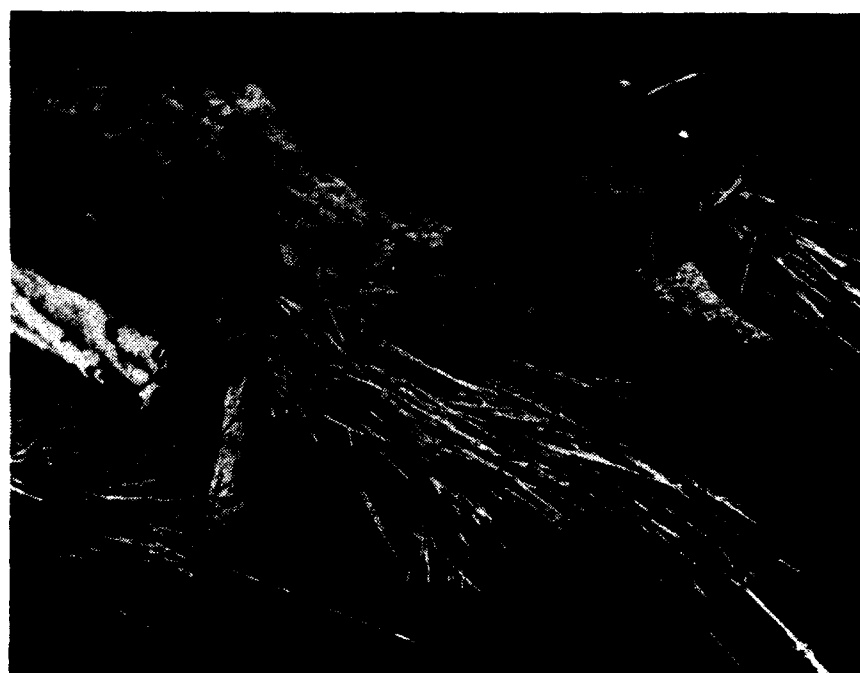
Figure 64. Scanning electron micrographs of fracture surfaces of Si_3N_4 infiltrated tows. Top panel: SiC coated Nicalon. Bottom panel: BN coated carbon fiber (T-300).

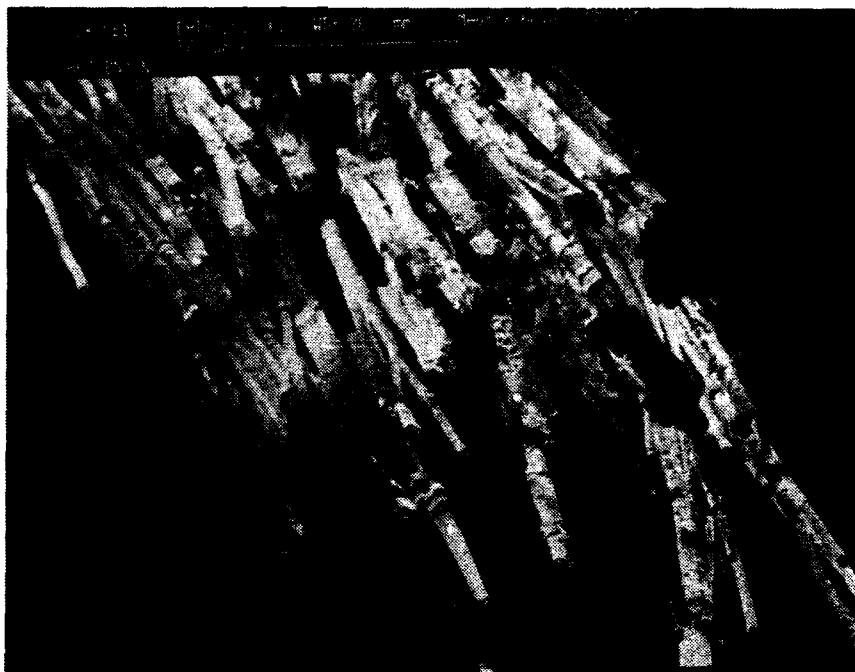
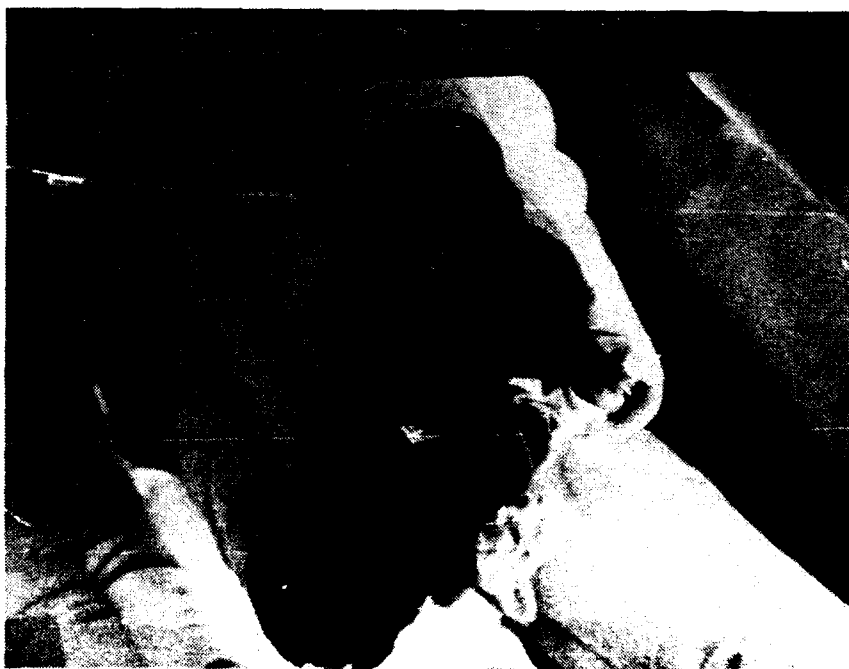
Figure 65. Scanning electron micrographs of fracture surfaces of Si_3N_4 infiltrated tows. BN coated HPZ.

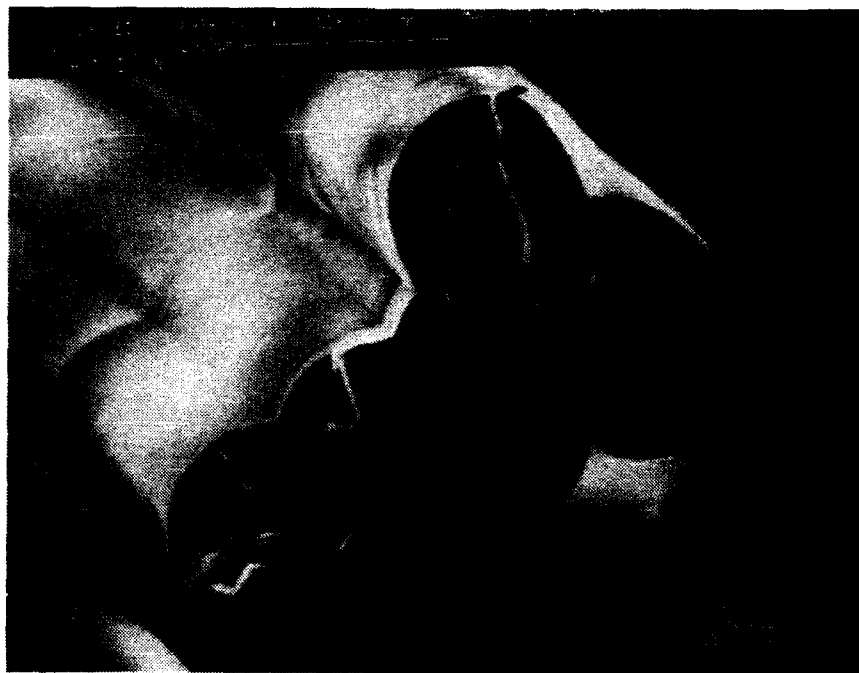
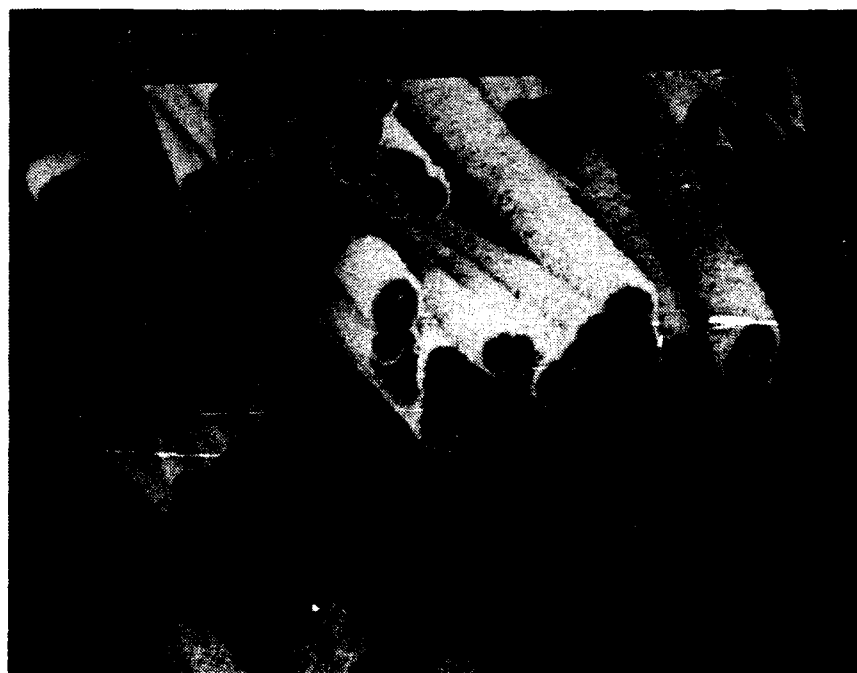
Figure 66. Scanning electron micrographs of fracture surfaces of Si_3N_4 infiltrated tows. Top panel: SiC coated HPZ. Bottom panel: HPZ with dual coating of BN/ Si_3N_4 .

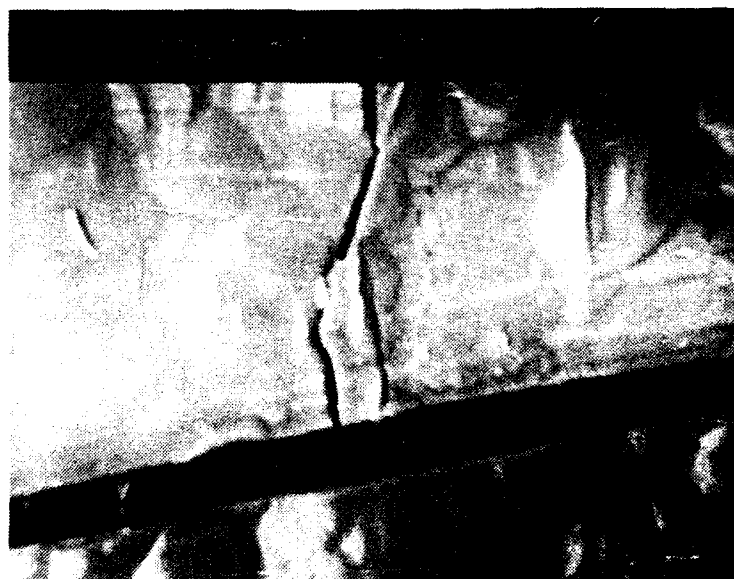
Figure 80. Scanning electron micrographs of polished BN-coated Nicalon in Si_3N_4 matrix showing crack deflection at interface. Upper panel 1.5 KX. Lower panel 4.0KX. A, Si_3N_4 matrix; B, crack; C, BN coating; D, Nicalon fiber.
